29 November 2021

TO: Board of Directors  
**Aquavista of Panama City Beach Owners Association, Inc.**

Subject: **Building Survey of the Property**

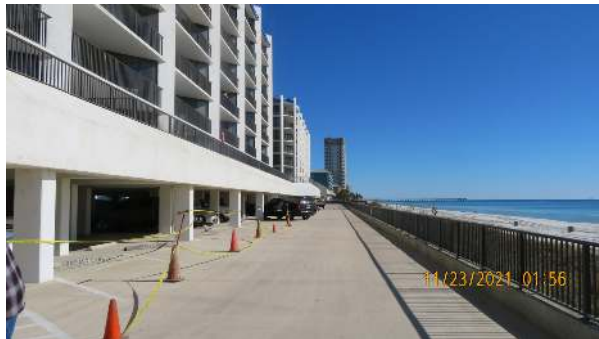
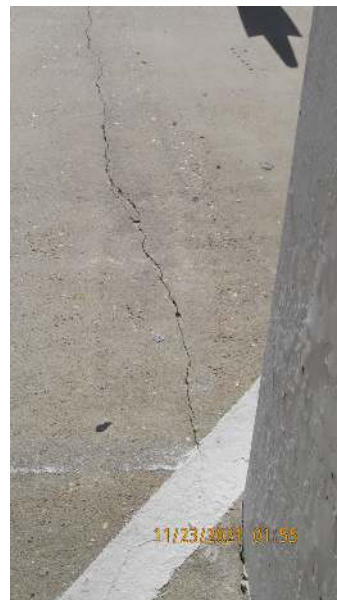
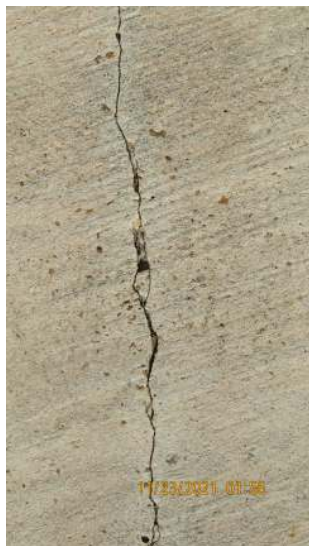
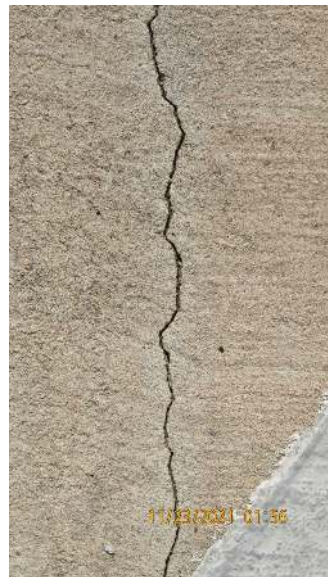
**Parking Deck:**

The above grade parking deck has multiple cracks running north and south about every 10 feet apart. This is allowing the salt laden water to penetrate through the deck.

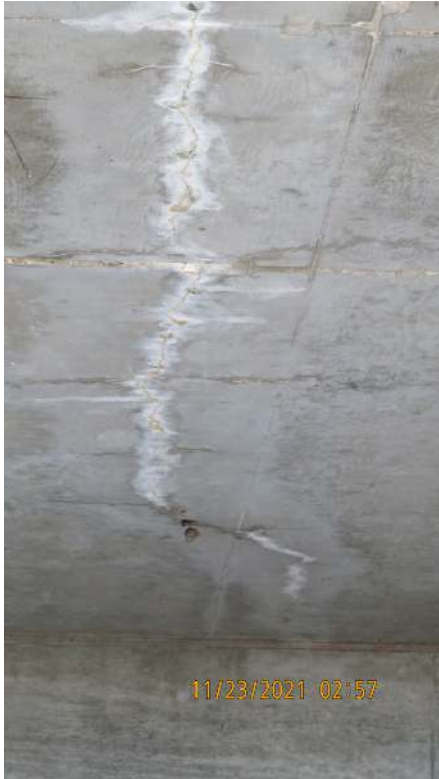
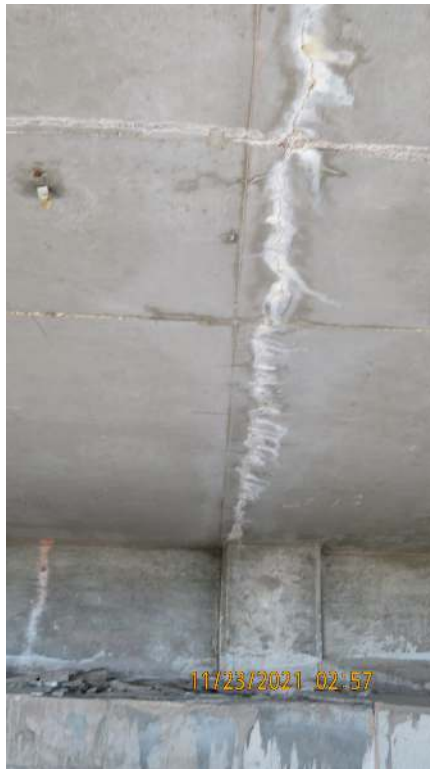
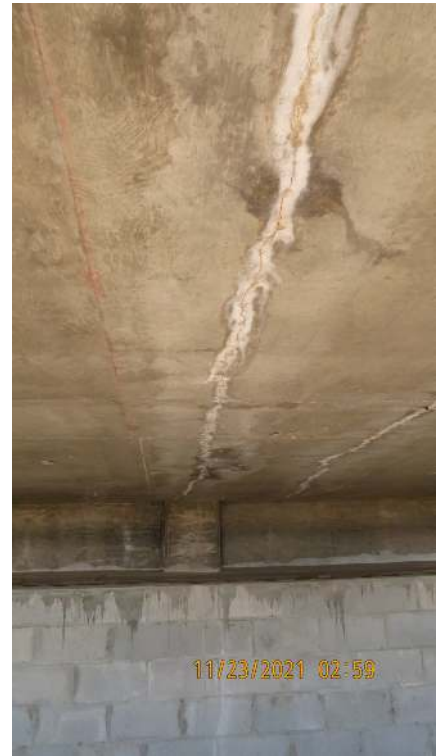
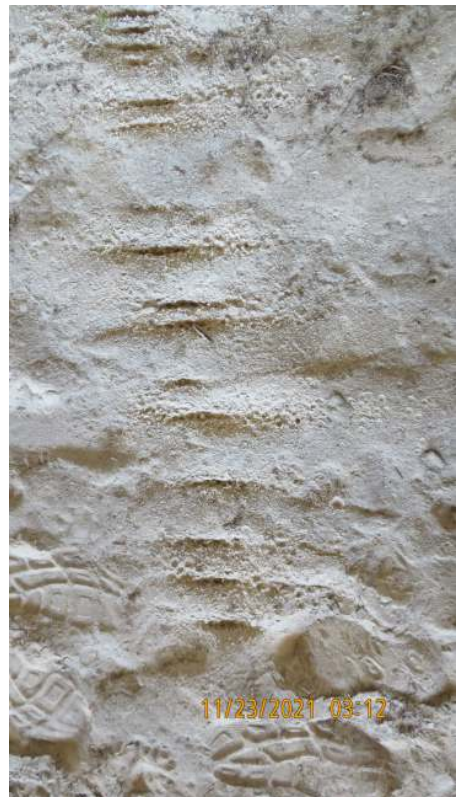
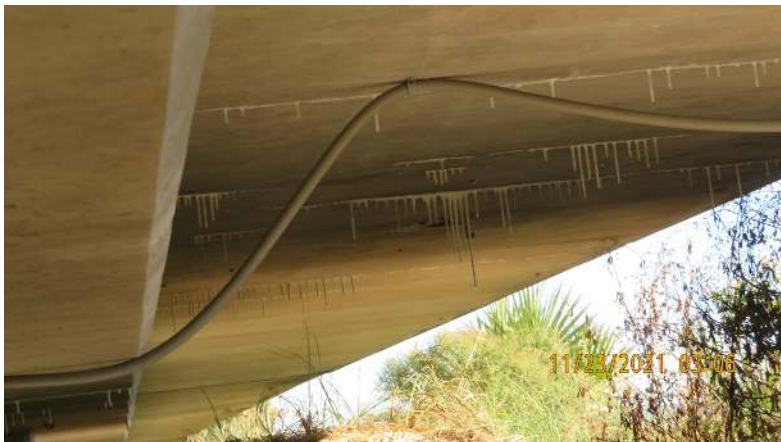
As can be seen in the below photographs taken underneath the deck, the cracks seen previously extend through the entire thickness of the deck.

This writer was surprised that the reinforcing steel within the deck had not significantly begun to rust since there was little visual rust seen as part of the laitance (the white residue). It is only a matter of time until this starts occurring. These cracks need to be sealed as part of the waterproof deck coating installation on the deck above. The water coming through the slab is not insignificant as can be seen in the drip lines made in the sand below.

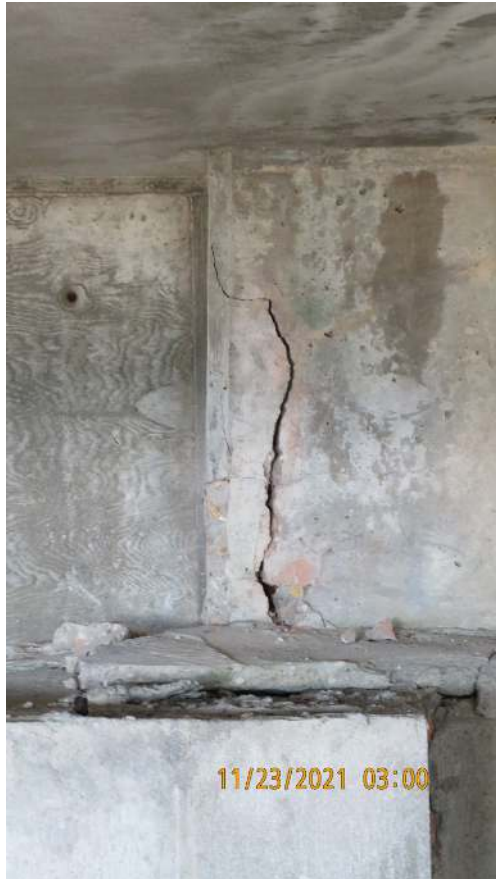
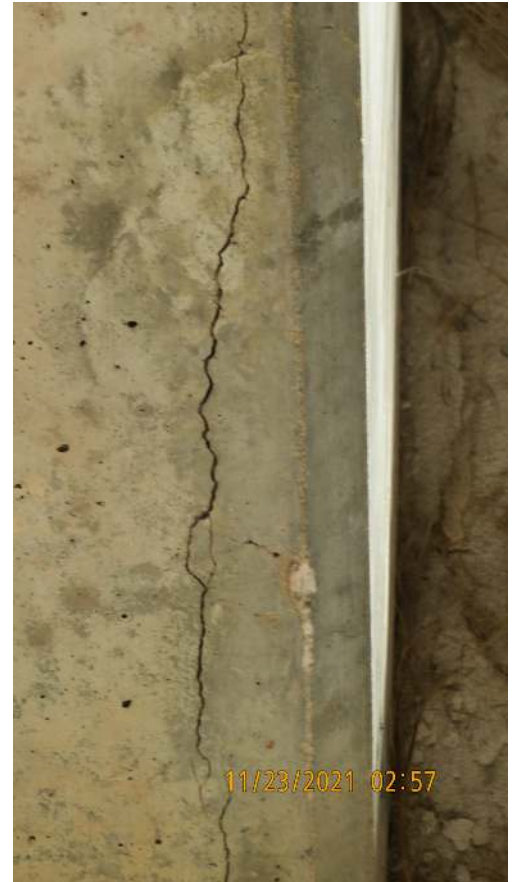
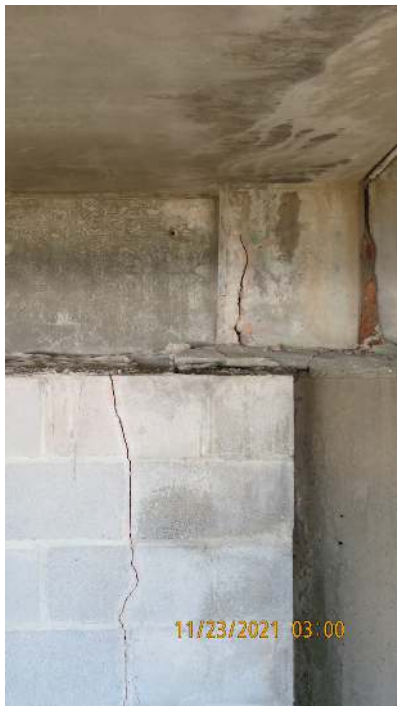
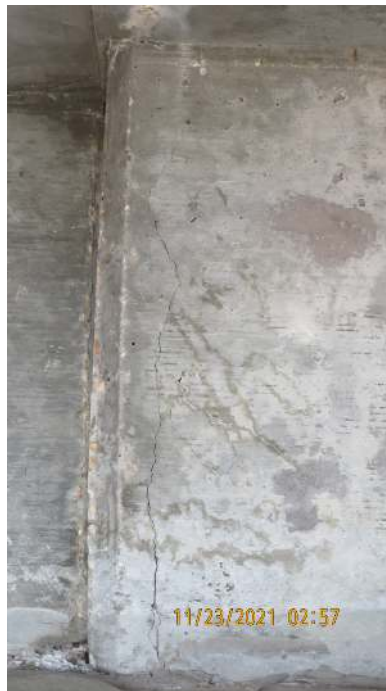
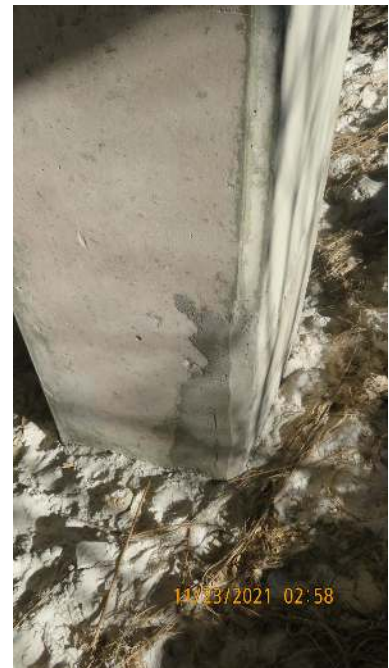
**Parking Deck Supporting Structure:**

While underneath the deck, the columns supporting the deck were inspected. A number of these columns had

significant cracks. Some of these vertical cracks disappeared into the sand below. As part of the concrete restoration work these would be considered full depth major concrete repairs.

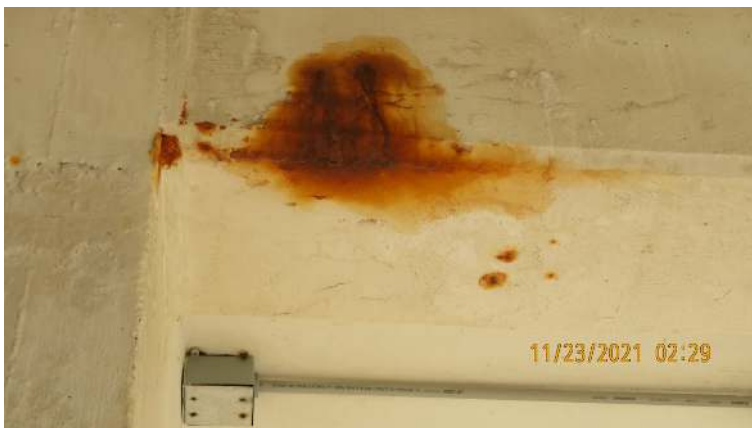
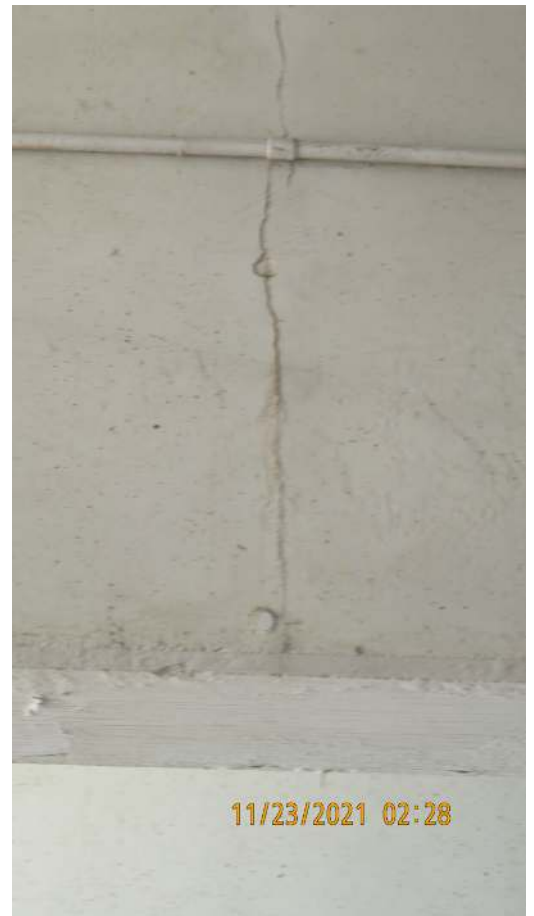
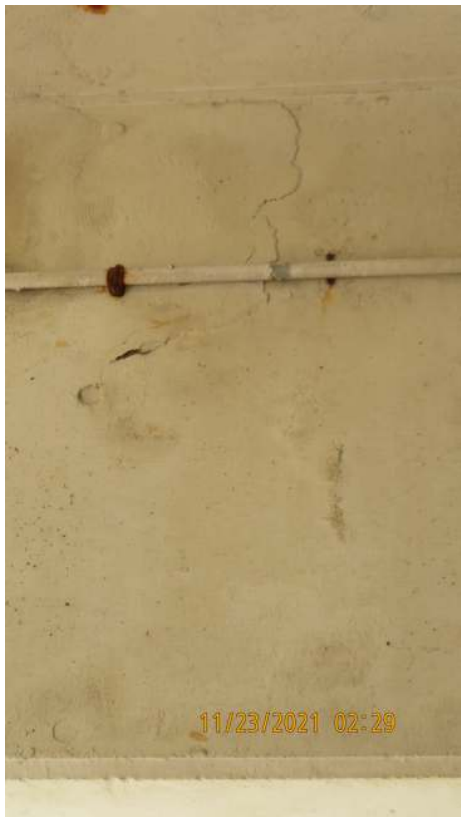
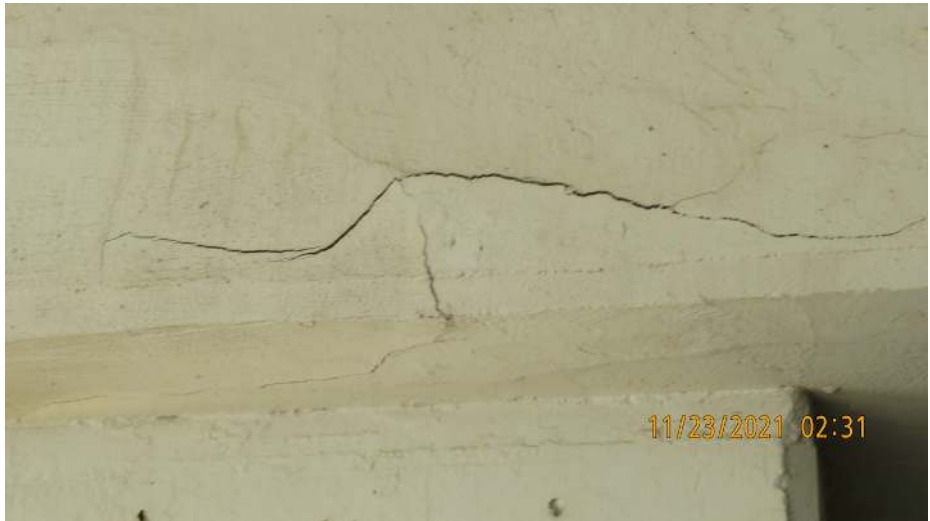
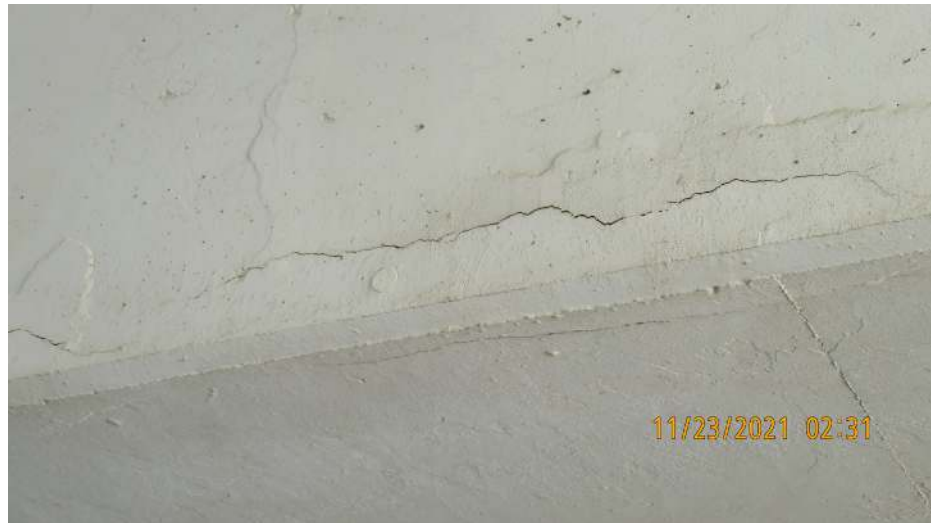
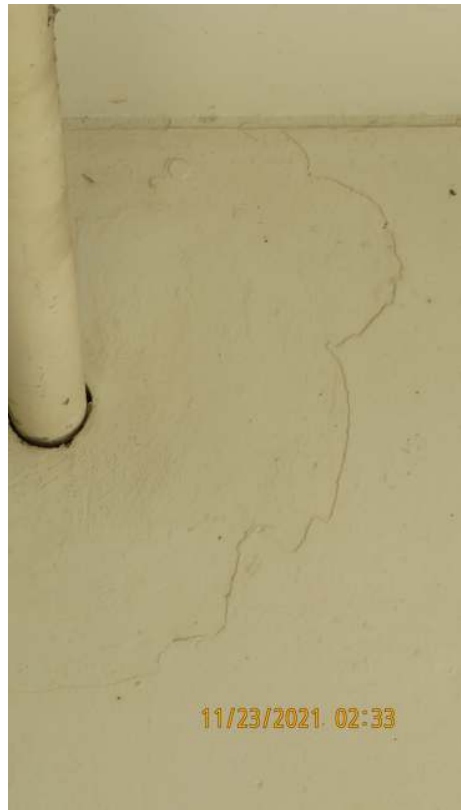
### Columns & Girders:

As can be seen in the adjacent and following page photographs, the primary girders and columns have structural cracks that should be repaired. In some cases, one can see that the reinforcing steel is beginning to rust and bleeding through the surface.

These types of cracks are not uncommon. Sometimes they are the result of water penetrating the girder but most of these appear to be caused by structural movement of the towers above.

These are also considered to be full-depth repairs which will be specified in the restoration documents.

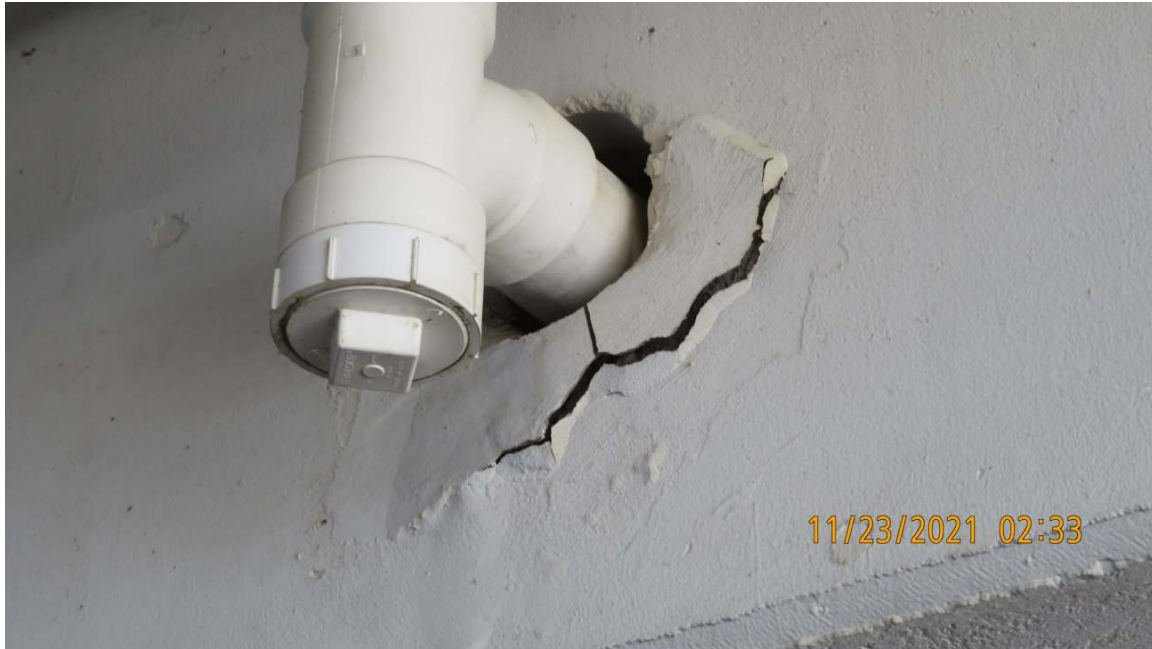
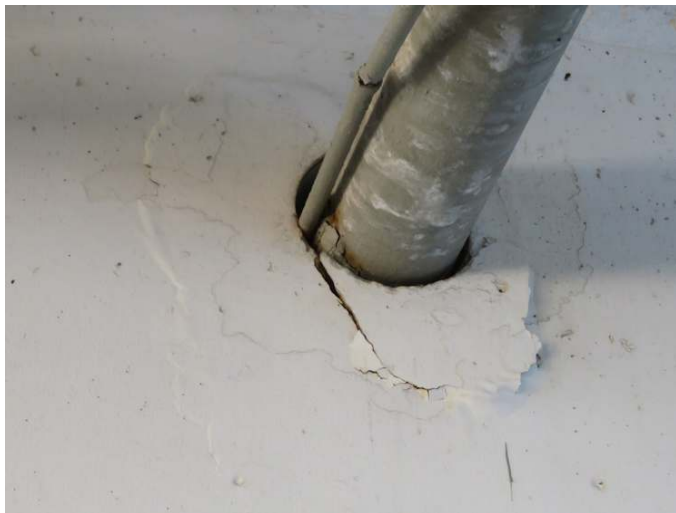
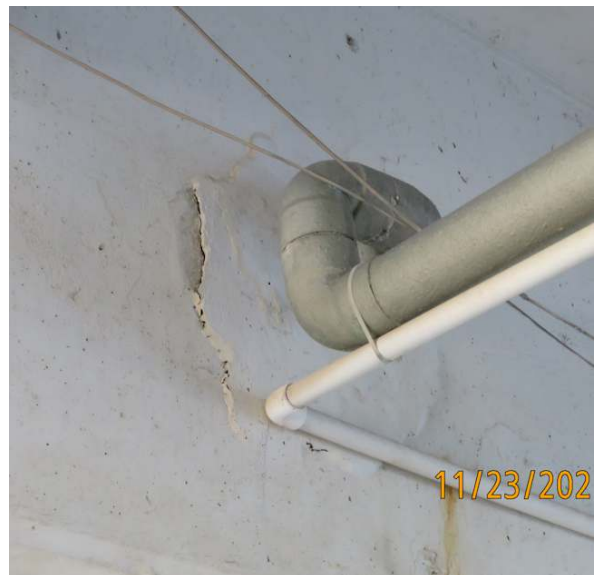
Major concerns are the large holes which penetrate through the girders as part of the piping system. As can be seen, the girders have significant cracks around the holes. Destructive testing will have to take place to determine if these holes must be reinforced with tubular steel.

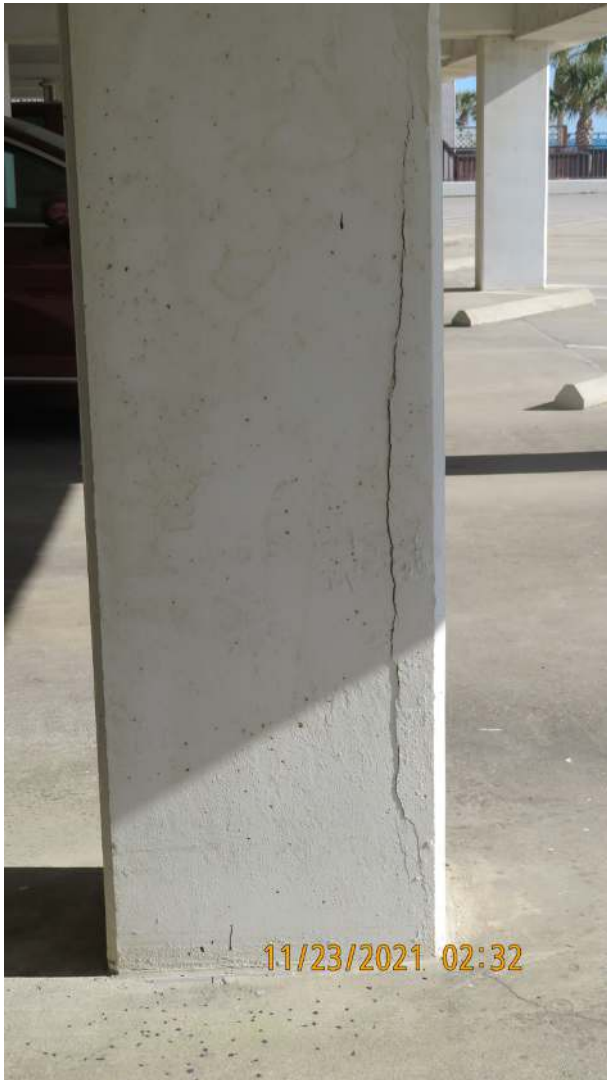
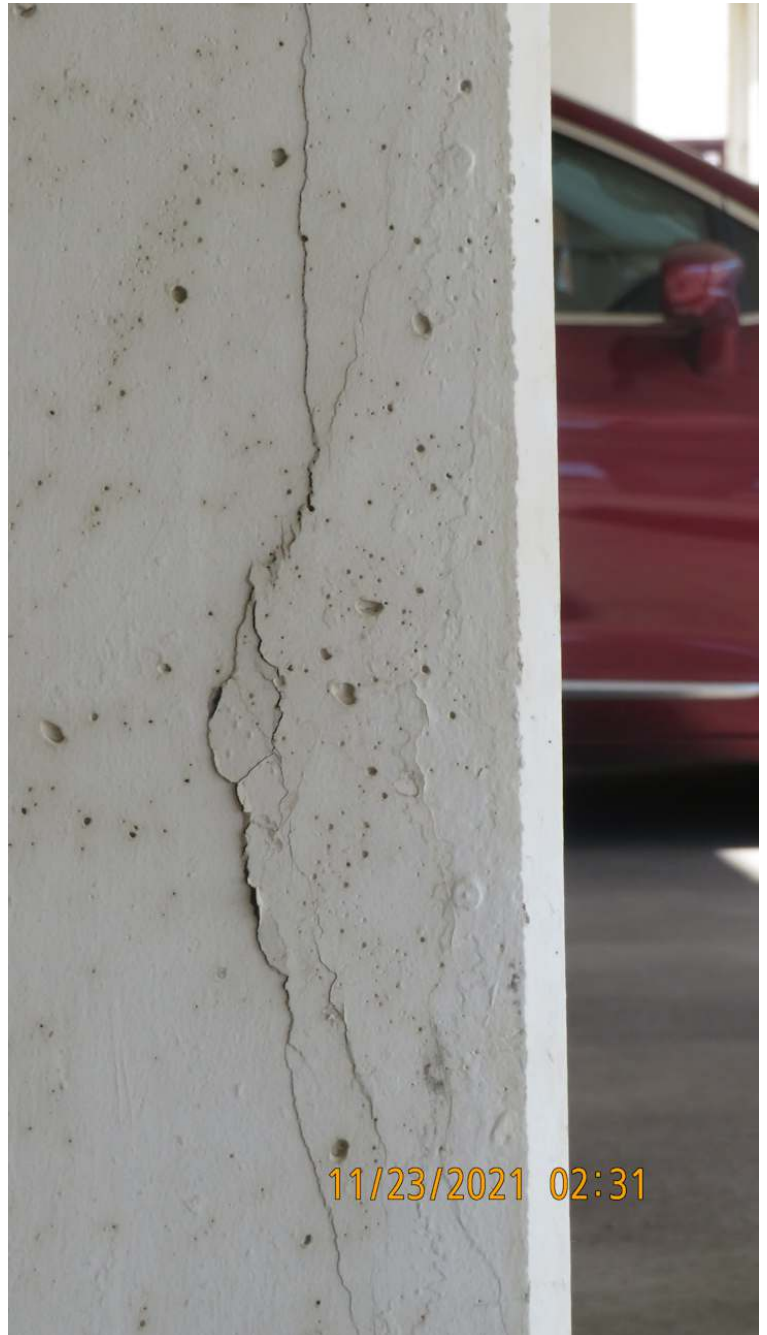
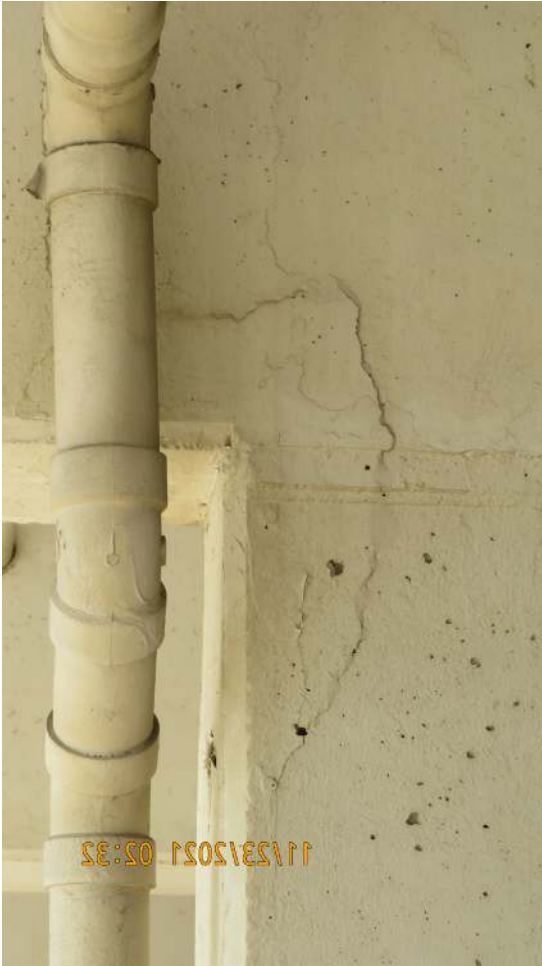
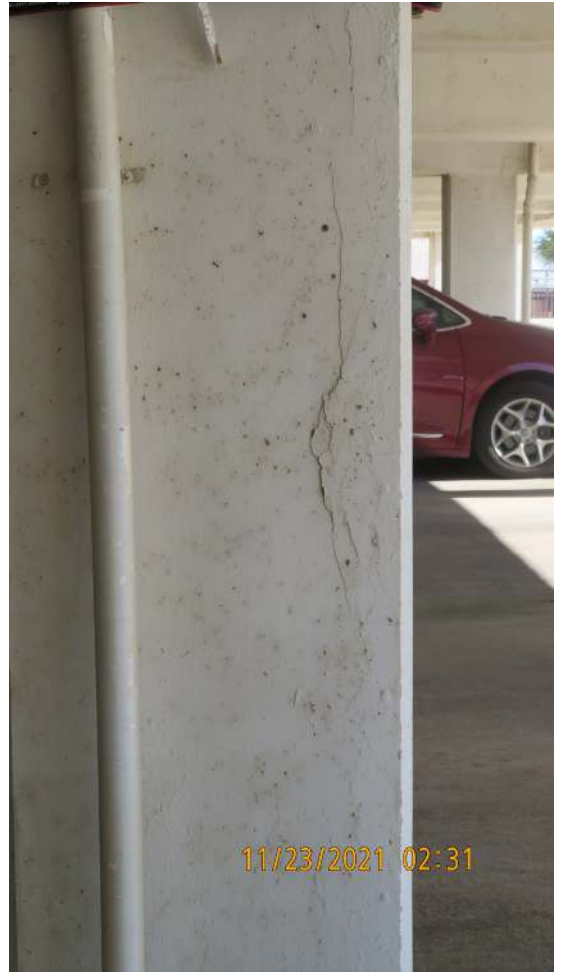
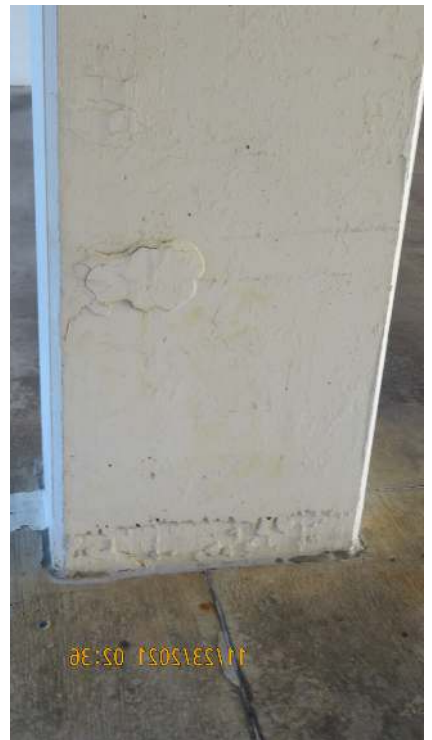
**Columns:**

There are multiple cracks in a number of columns. As stated in the prior comments, these are also considered full-depth repairs which take a significant amount of concrete removal to adequately repair the damage.

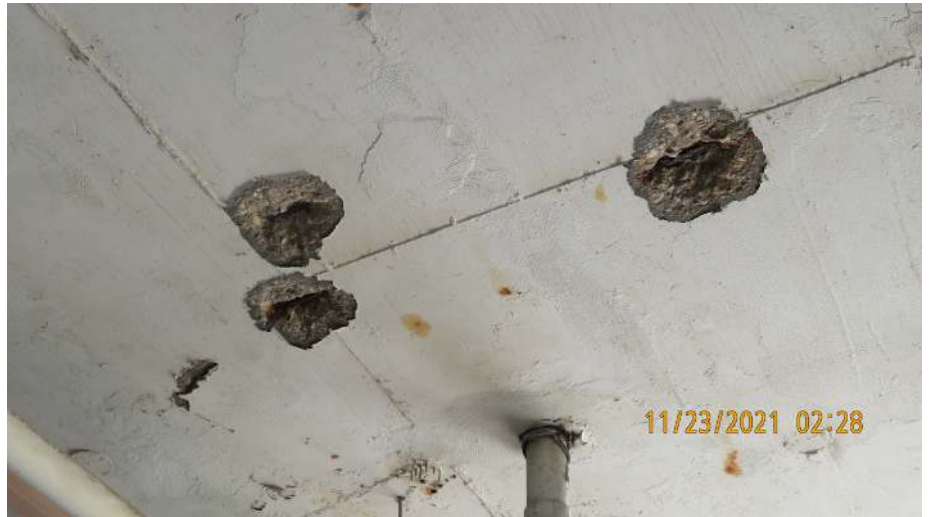
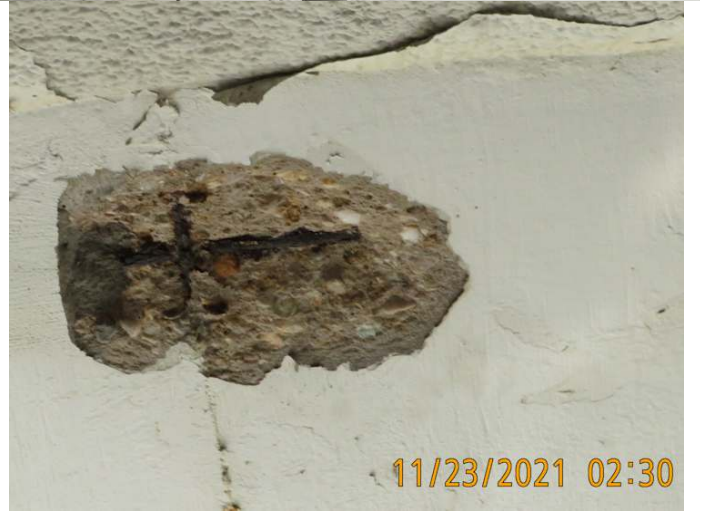
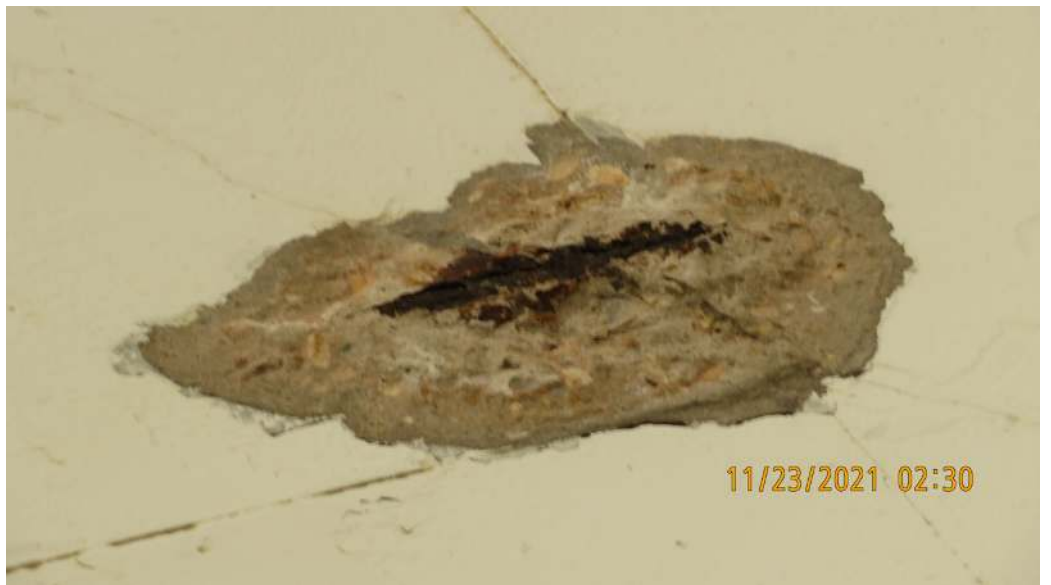
**Deck Overhead:**

There are multiple concrete spalls in the concrete overhead deck. These spalls are mostly under the pool slab between the two buildings.

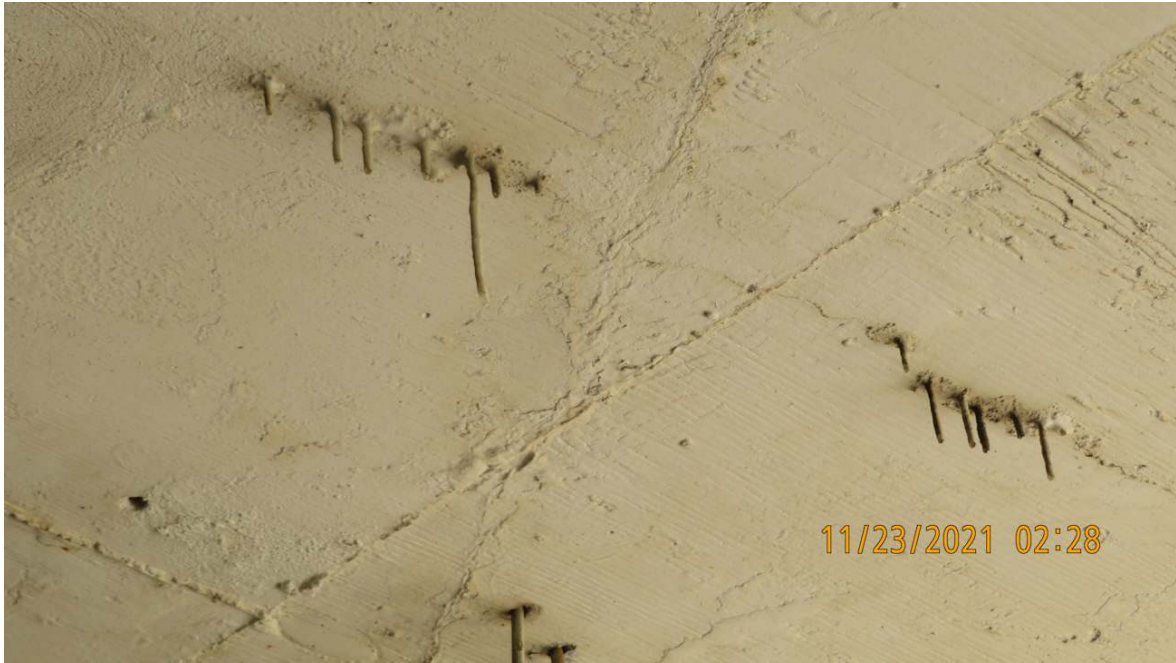
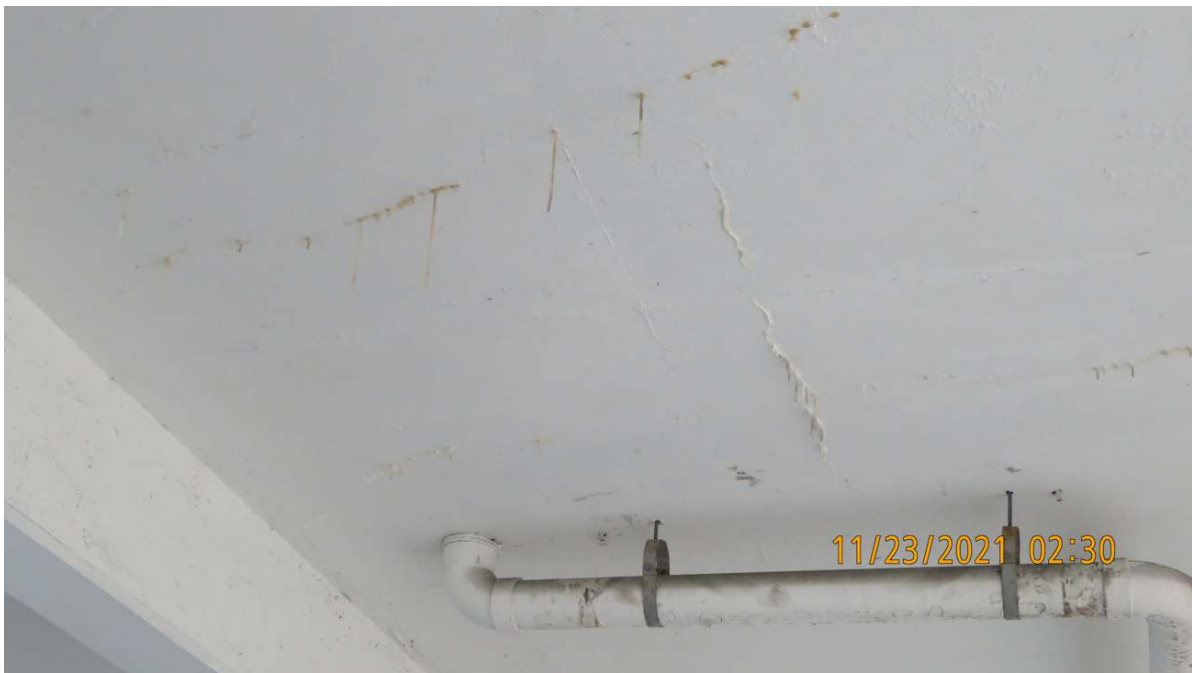
In addition to the spalls there are number of locations where the concrete slab has linear cracks allowing water to penetrate through the deck, similar to what is happening below in the parking deck. These calthemite stalactites are the result of saltwater causing calcium to be leached from the concrete. Over time, this weakens the concrete and leads to the reinforcing steel rusting.

As in the parking decks, these cracks should be sealed to prevent rusting of the reinforcing steel in the slab.

To do so the pavers surrounding the pool on the surface will have to be removed. Once removed, a waterproof coating should be applied to the surface, like what has been applied on the balconies of the towers.

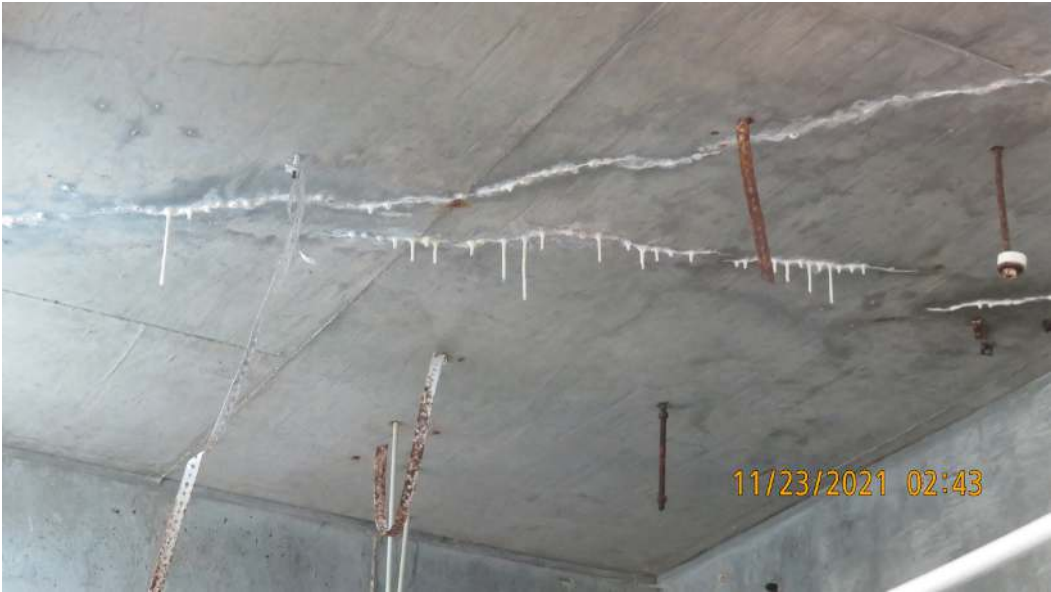
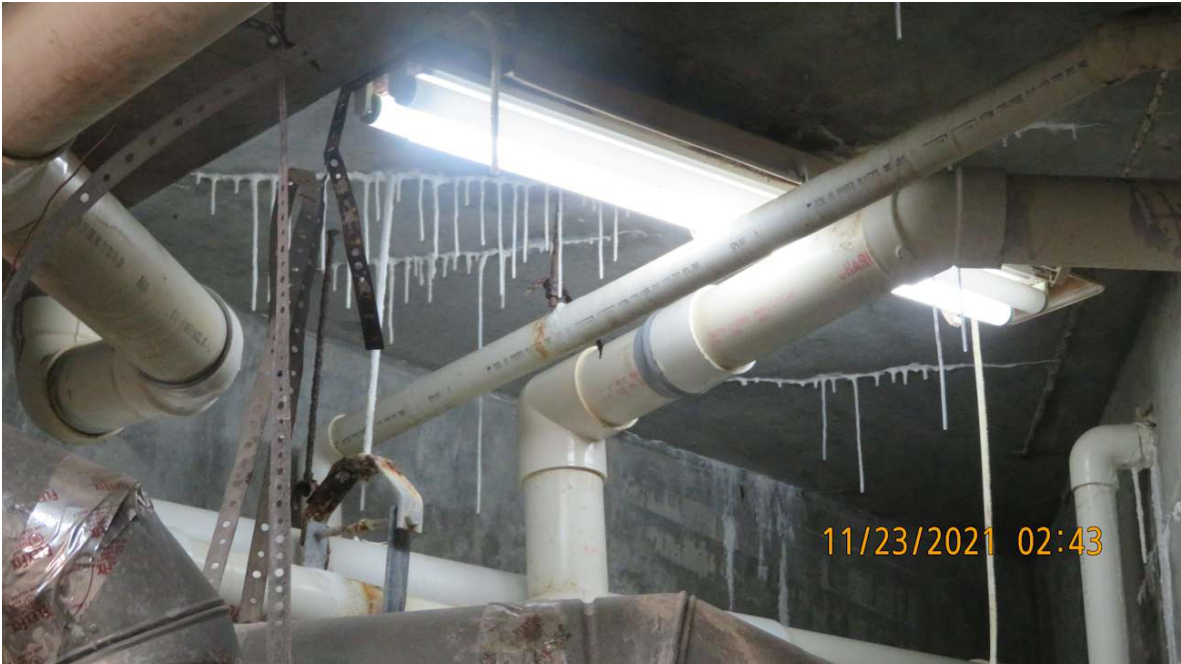
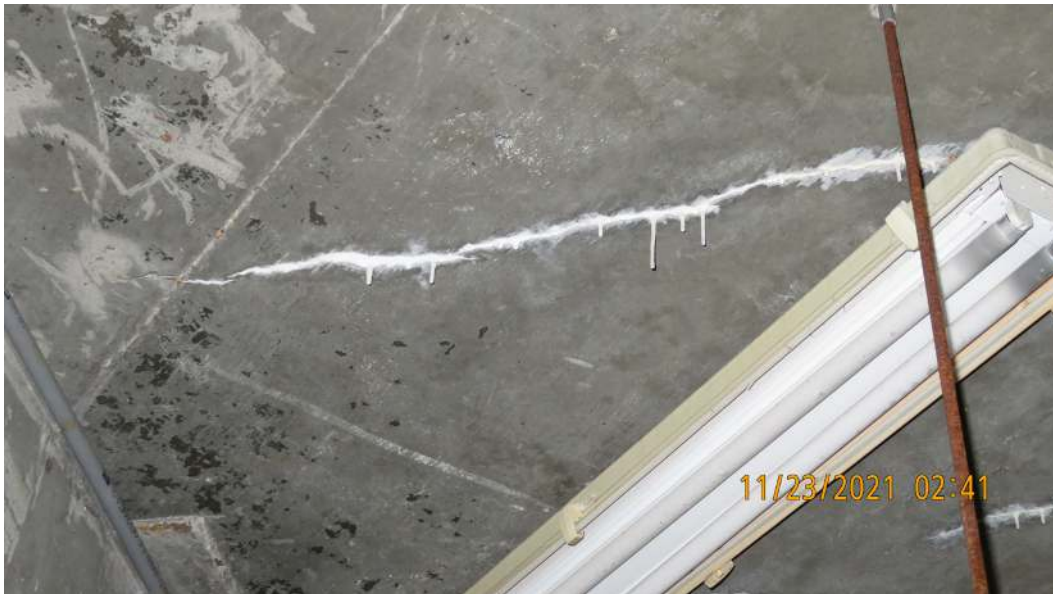
The following photographs were taken in both the pool and fire control equipment rooms. As one can see there are significant cracks throughout the slab below the pool deck.

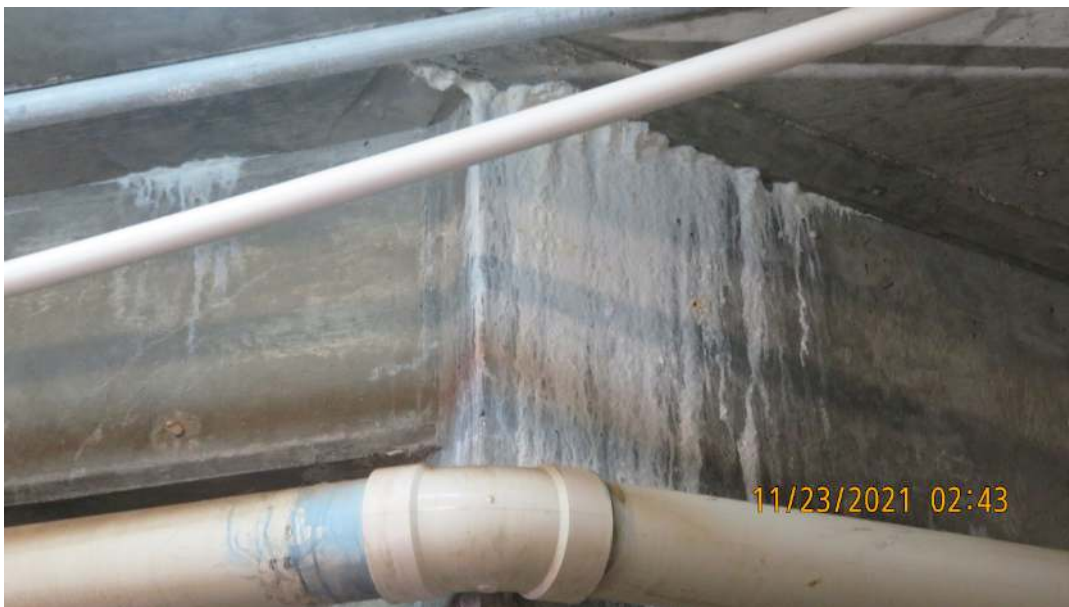
These deposits are occurring between the pool wall and the pool deck.

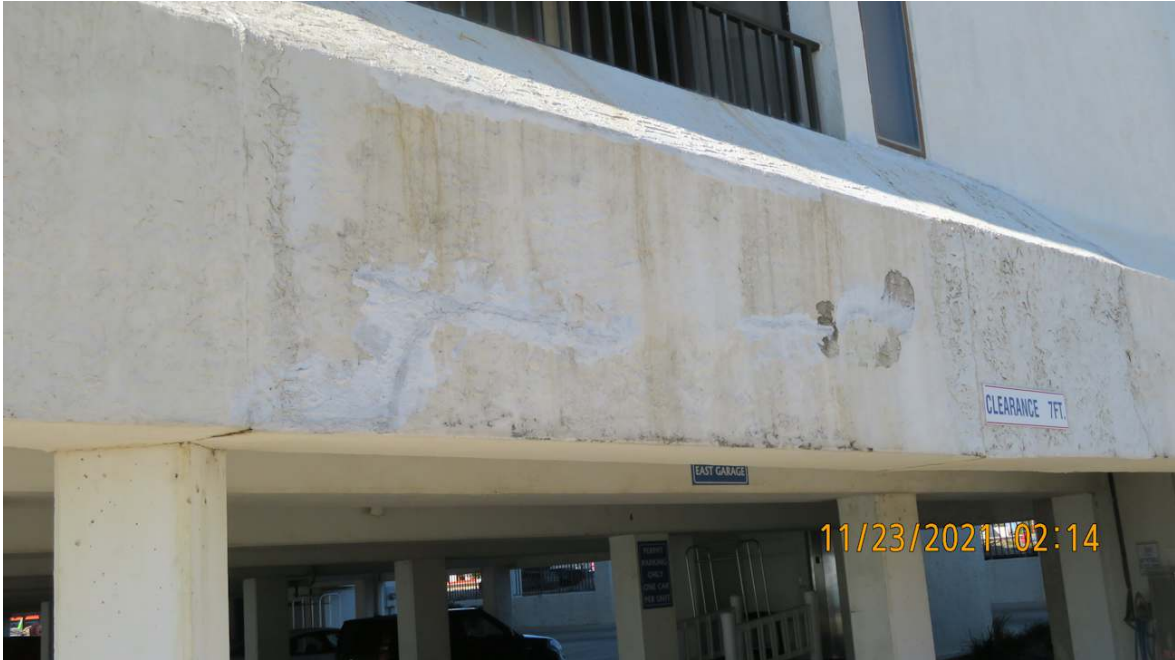
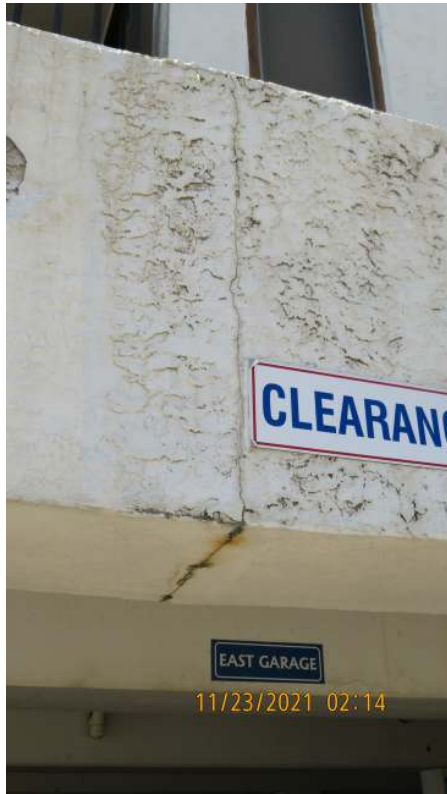
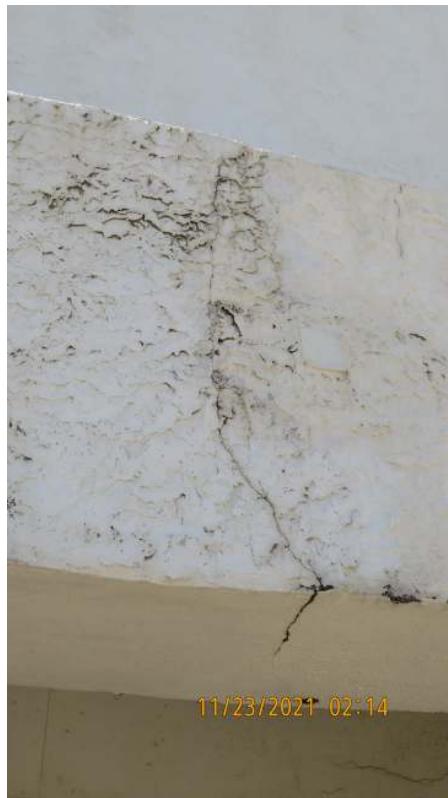
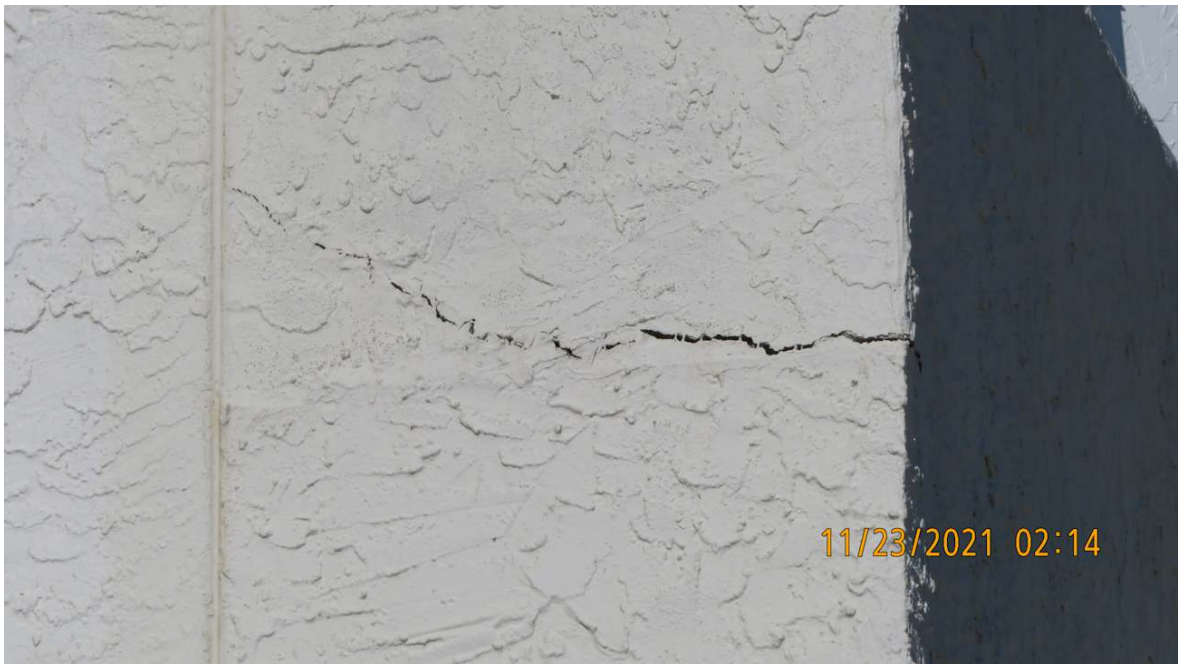
**Perimeter Cantilevered Decorative Band around the Deck:**

This band has numerous cracks in the stucco cladding. There have been numerous attempts to repair these cracks in the past. Further investigation is required to determine how the band is constructed to specify the best means and methods of repairing the cracks.

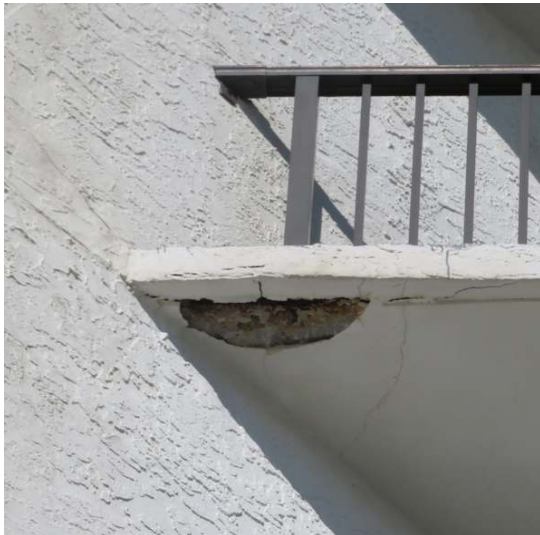
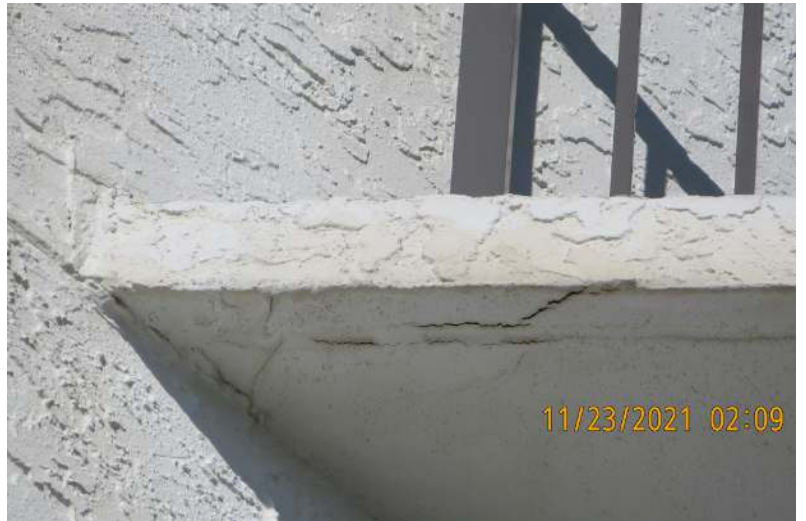
### **Slab Edge Cracks:**

Both towers are experiencing slab edge cracks which is not unusual given the age of the building. The chlorides of our salt laden atmosphere have penetrated the slab edges rusting the steel, thus leading to the spalls.

The state of these spalls is such that they can be repaired without extensive demolition of large areas of the balconies. However, without appropriate repairs we have seen where balconies had to be reconstructed.

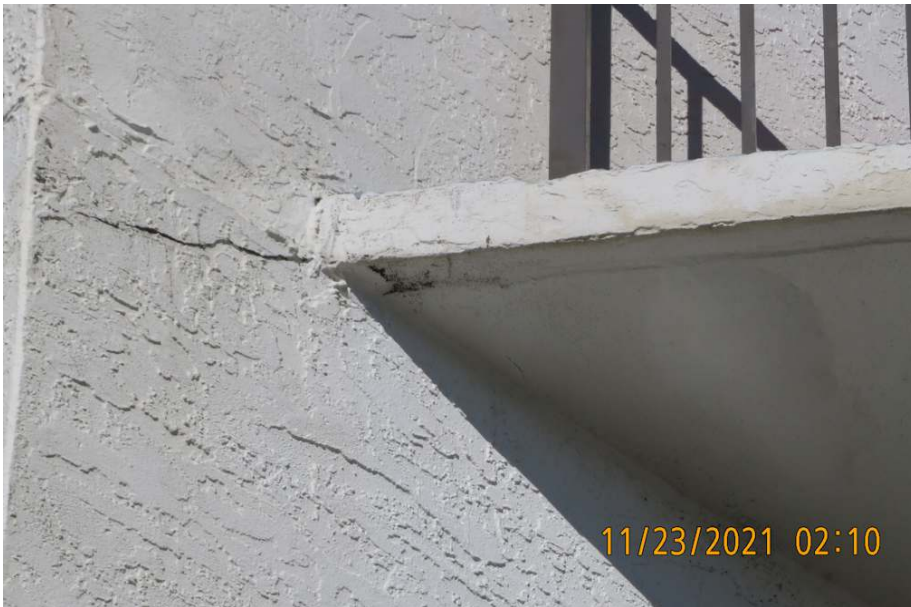
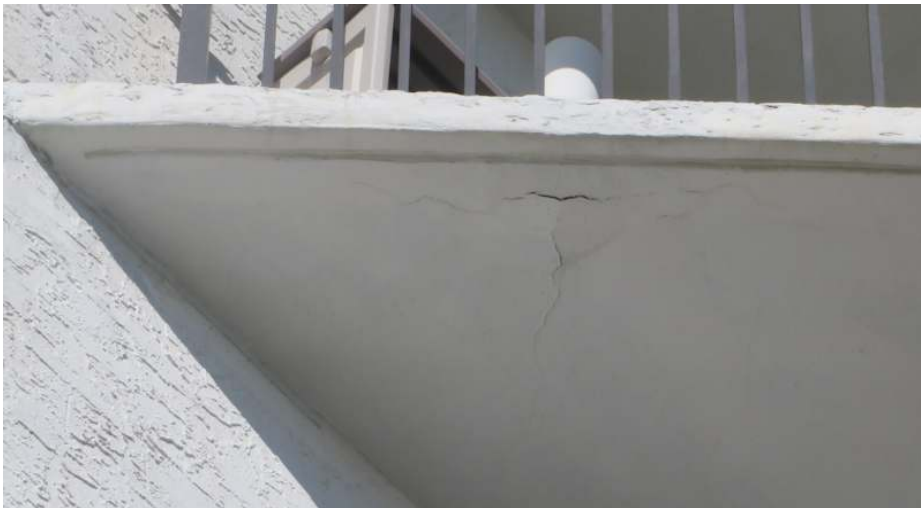
These two photographs below show the early signs of concrete that is about to spall, similar to the photographs on the previous page.
