29 November 2021

TO: Board of Directors  
**Aquavista of Panama City Beach Owners Association, Inc.**

Subject: **Building Survey of the Property**

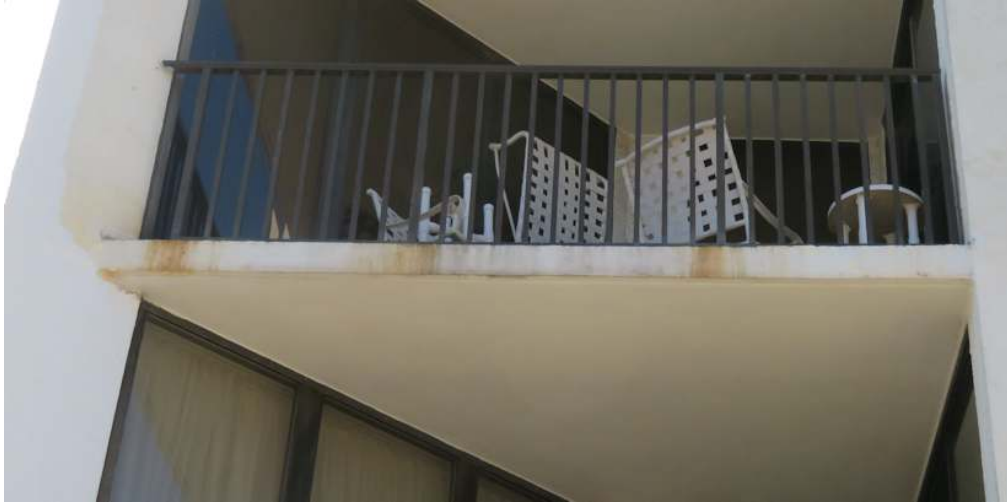
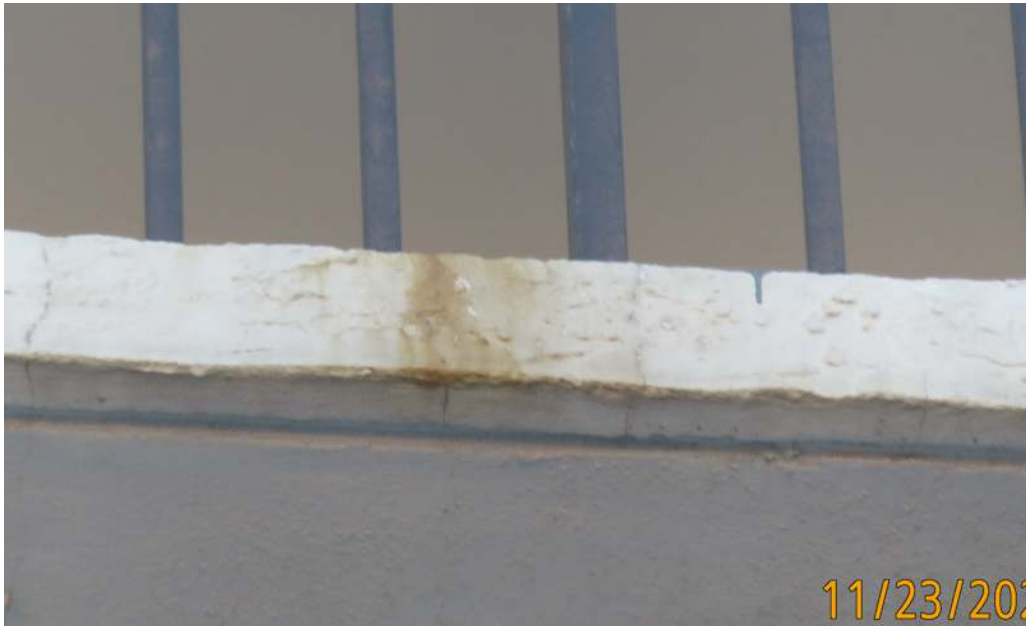
There are signs of rust stains on some of the balcony slab edges. This could be rusted rebar coming to the surface of the slab or could be rust from metal porch furniture legs running down the slab edge.

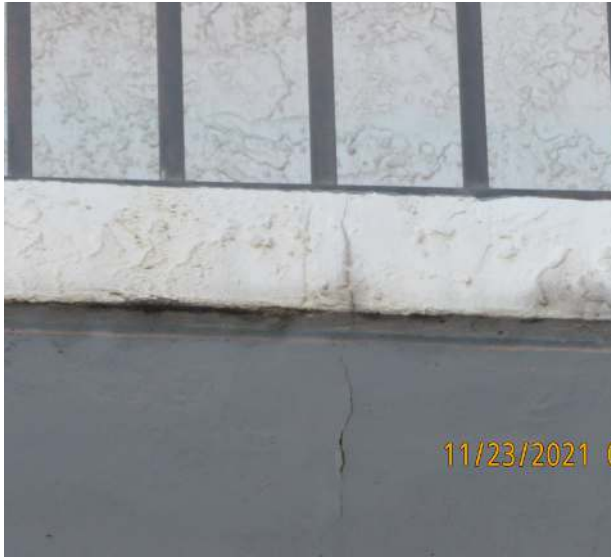
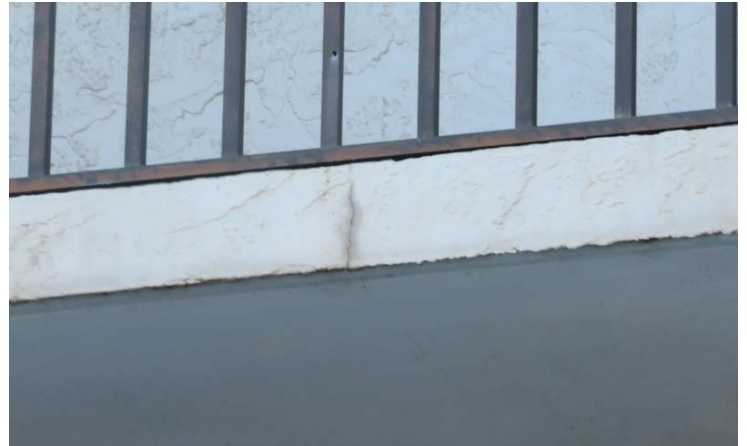
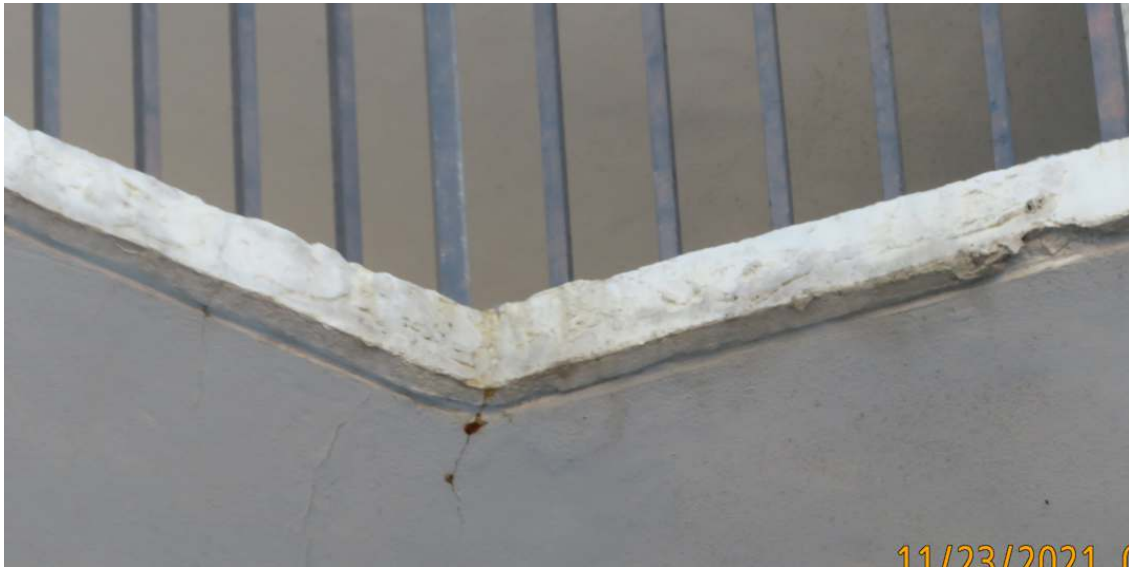
### Walkway Slab Edges:

The walkway slab edges are beginning to show cracks and the early signs of concrete spalls in the overhangs.

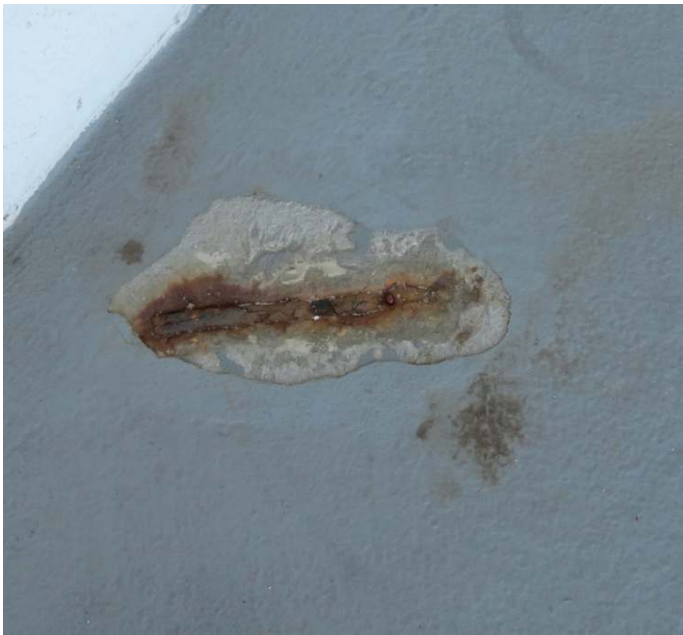
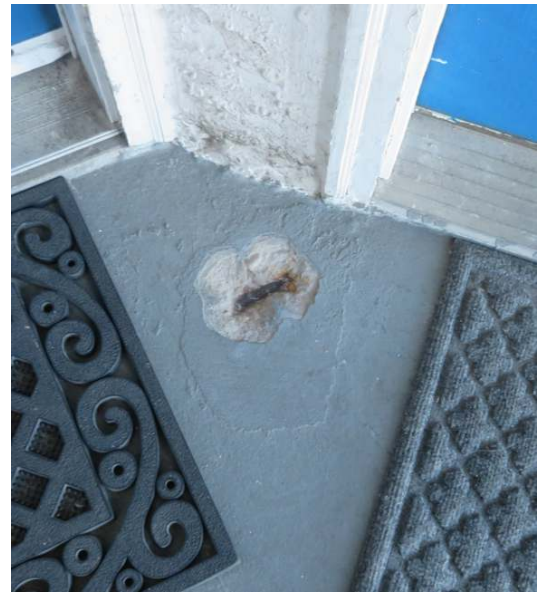
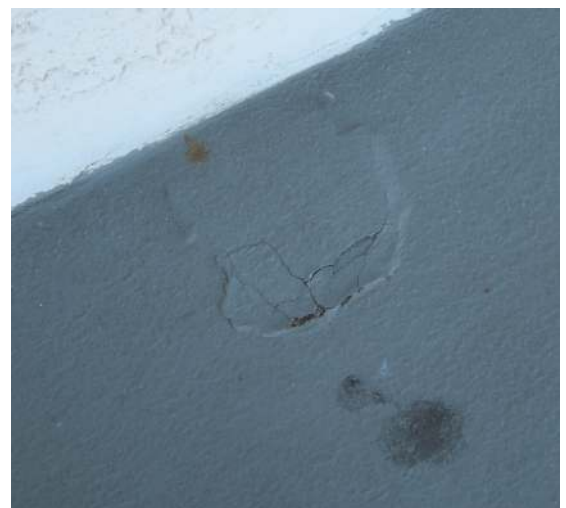
## Walkway Surface Spalls:

The walkways do not have a quality waterproofing applied to the surface. This is allowing water to penetrate the slab and rusting the reinforcing steel. The surface spalls can be repaired using standard ICRI (International Concrete Repair Institute) repair methods, which are included in all our project manuals for contractors to follow.

Without proper waterproofing of the surface, these types of spalls will continue to increase throughout the walkways, becoming more numerous over time.

Please know that the length of the repair will be three to four times the length of the exposed rusted reinforcing bar.

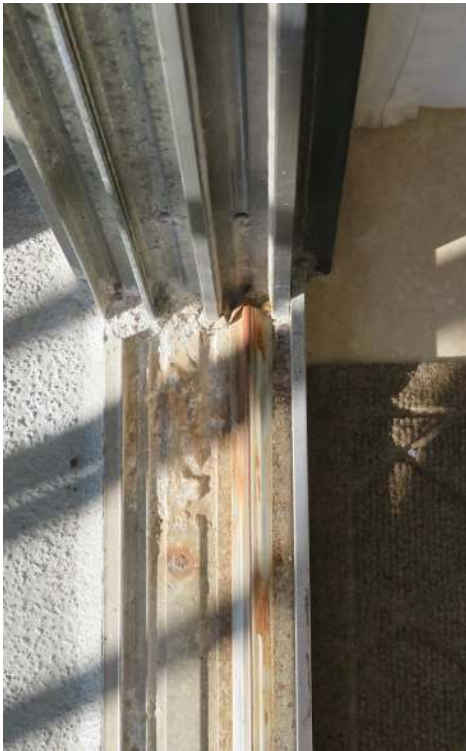
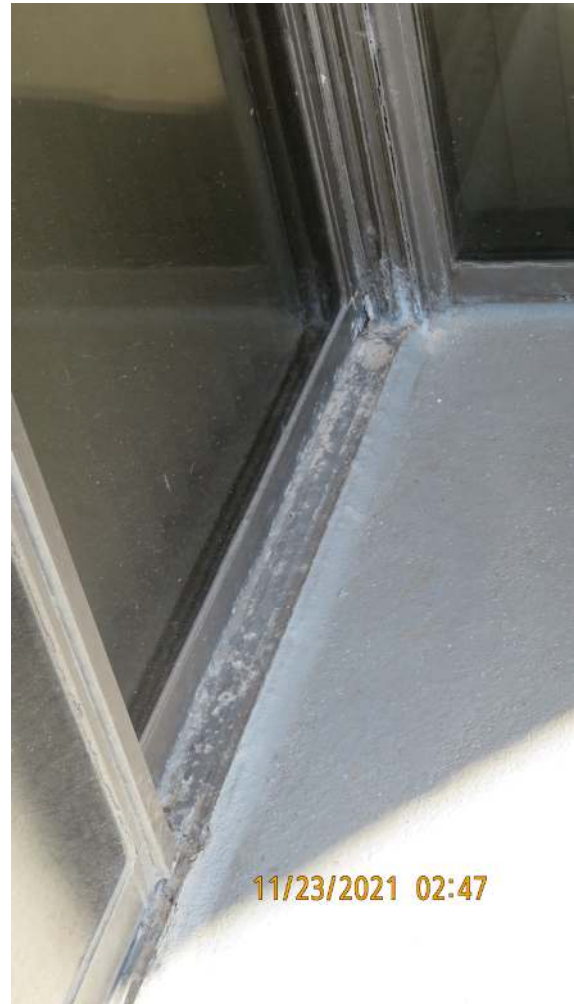
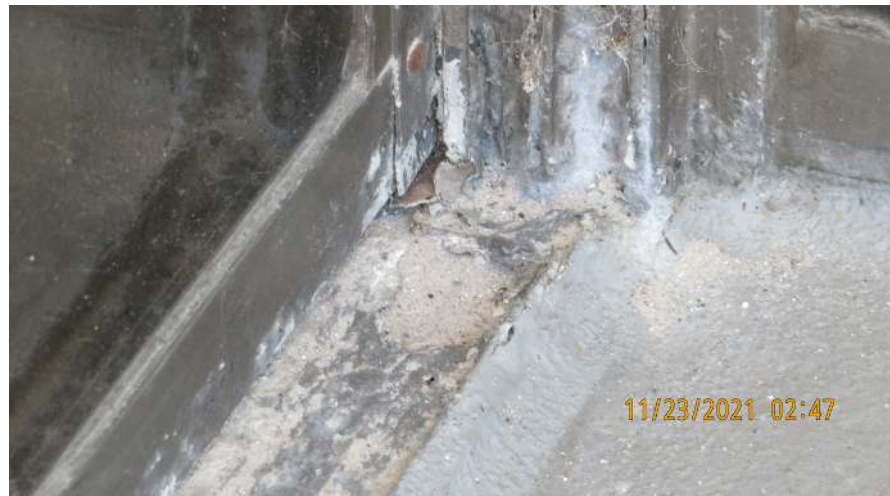
### Sliding Glass Doors and Windows:

The sliding glass doors and windows throughout the buildings have exceeded their service life.

The aluminum thresholds and frames are deteriorated well beyond the ability to be repaired.

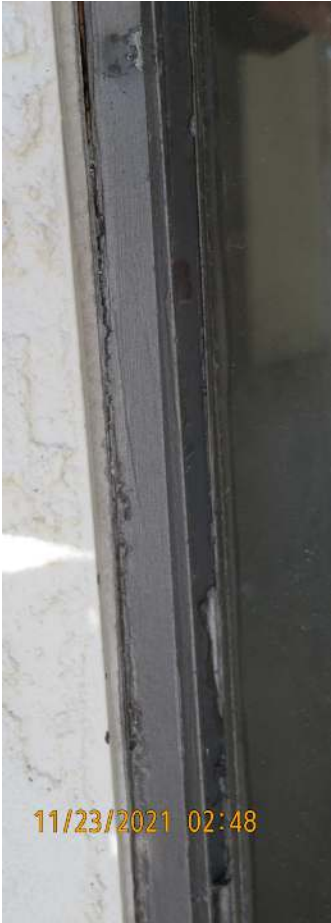
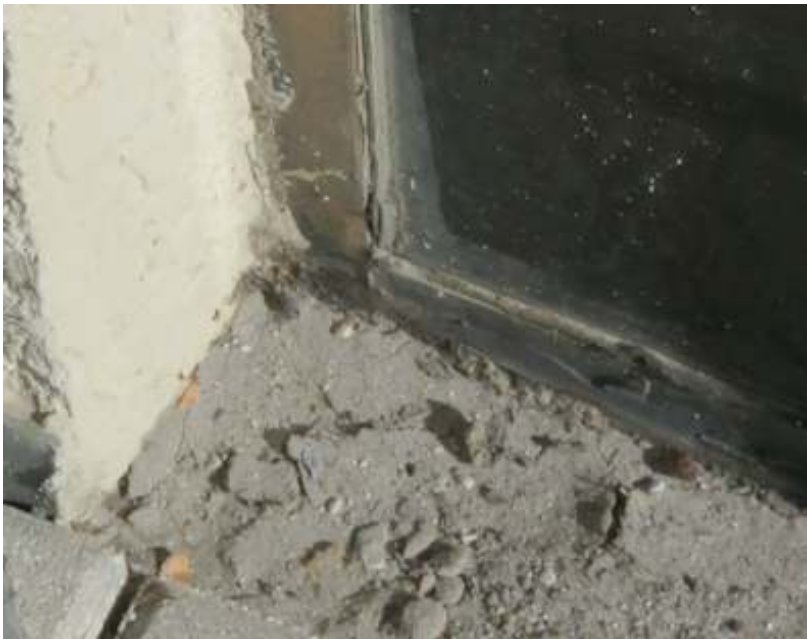
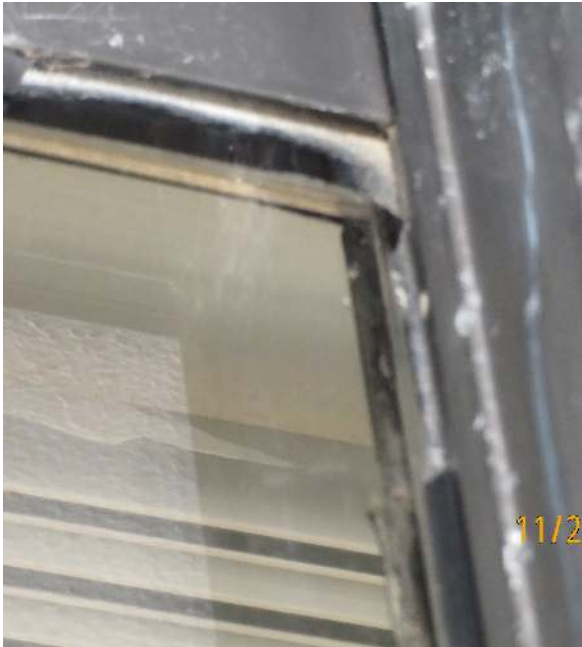
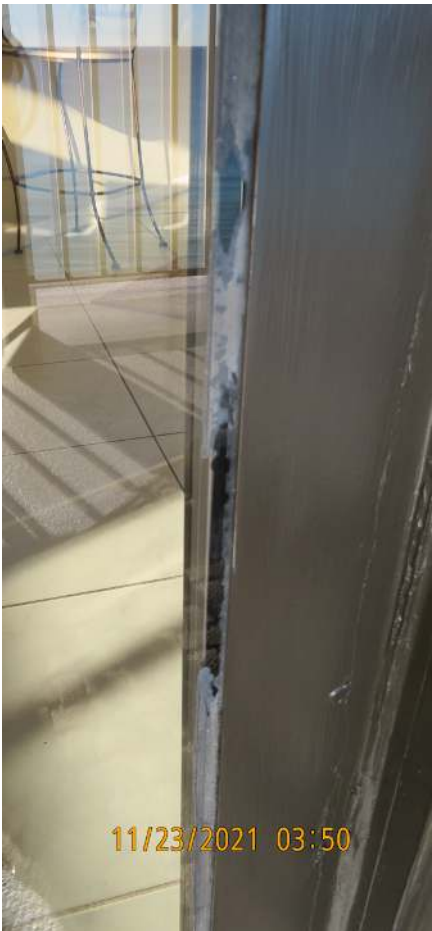
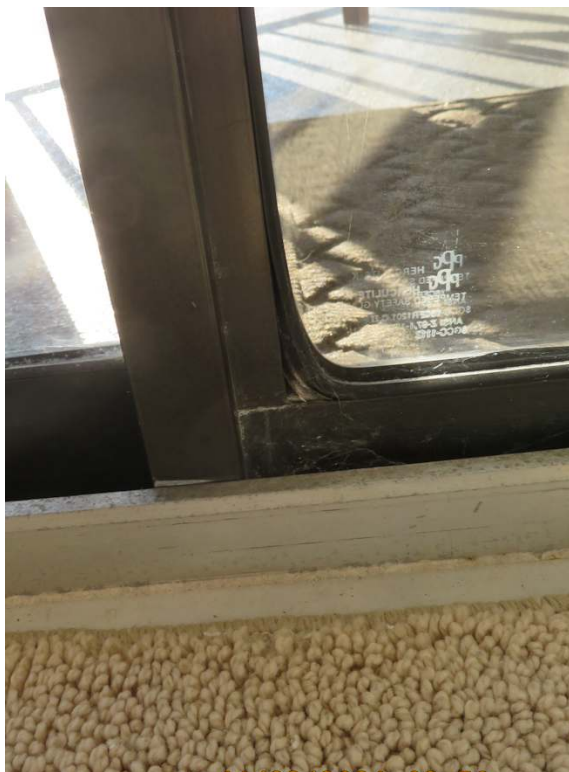
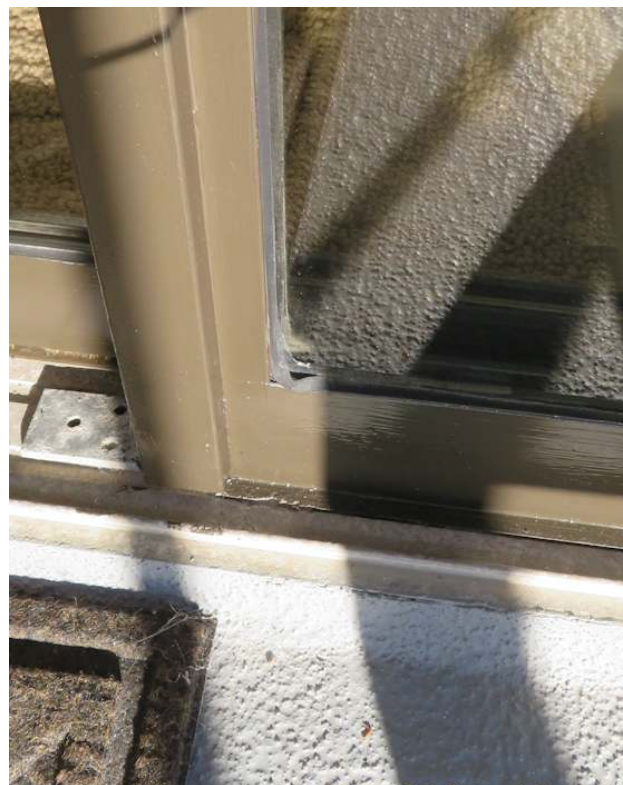
Gaskets between the glass in the aluminum frames have failed.

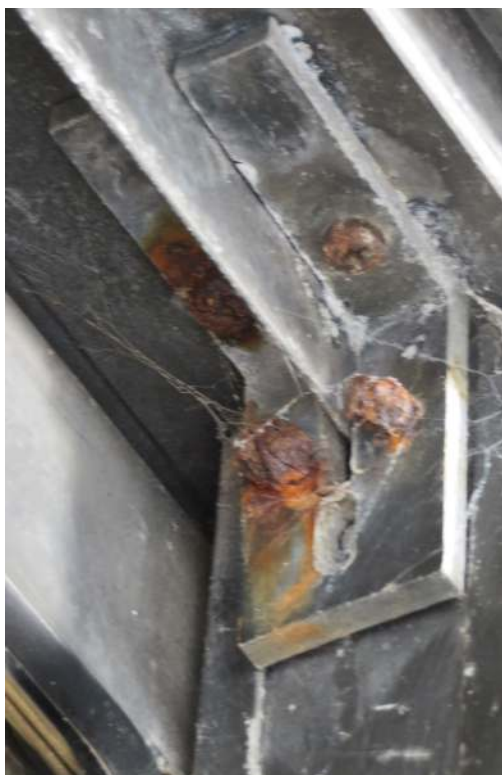
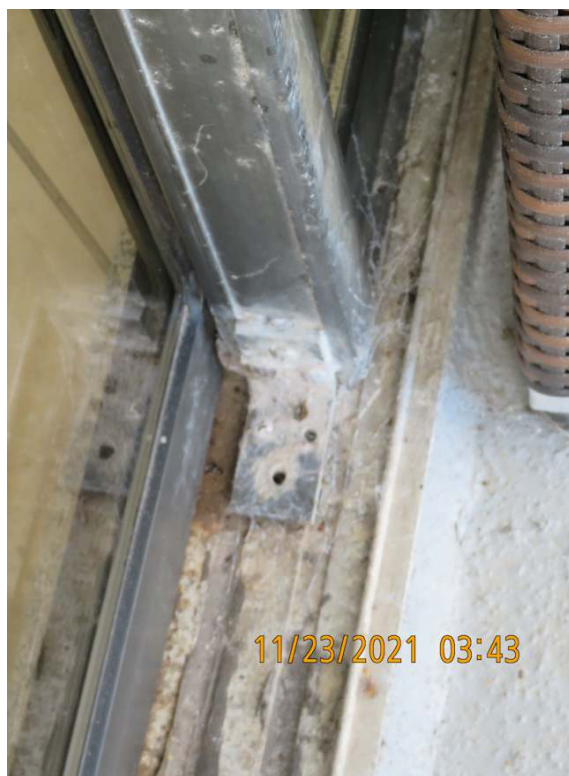
The anchoring hardware connecting the doors to the building has deteriorated and no longer functions as a structural connection.

This writer believes that if Hurricane Michael's winds had been from the Southeast, many of the doors and windows would have imploded.

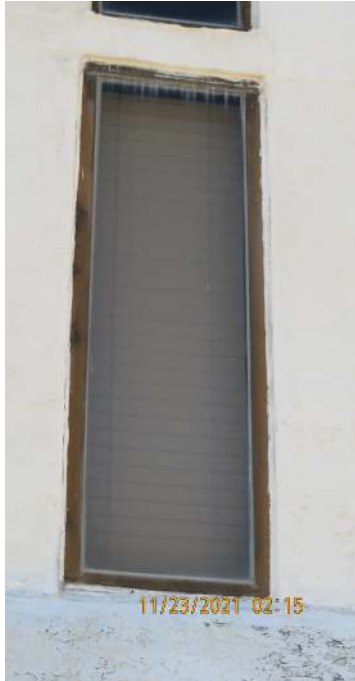
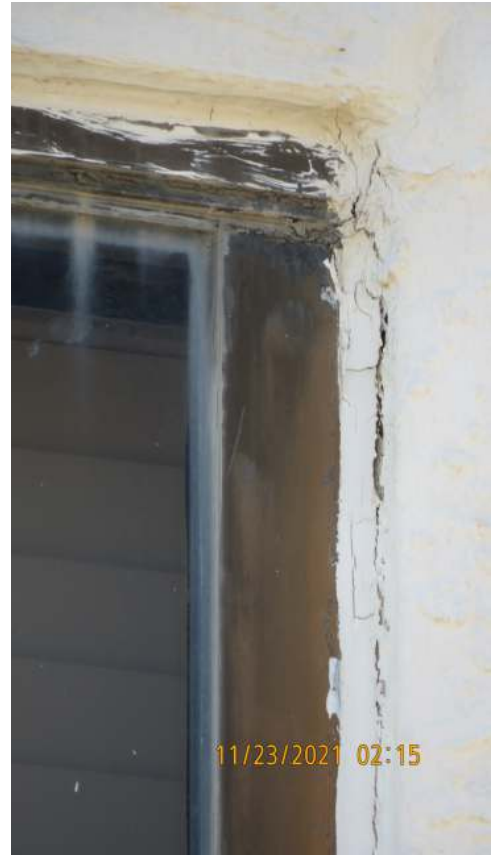
The sealant joints between the aluminum frames and the stucco have deteriorated and broken down. The joints have ceased to operate as a true expansion joint to allow movement between the aluminum frames and the wall.

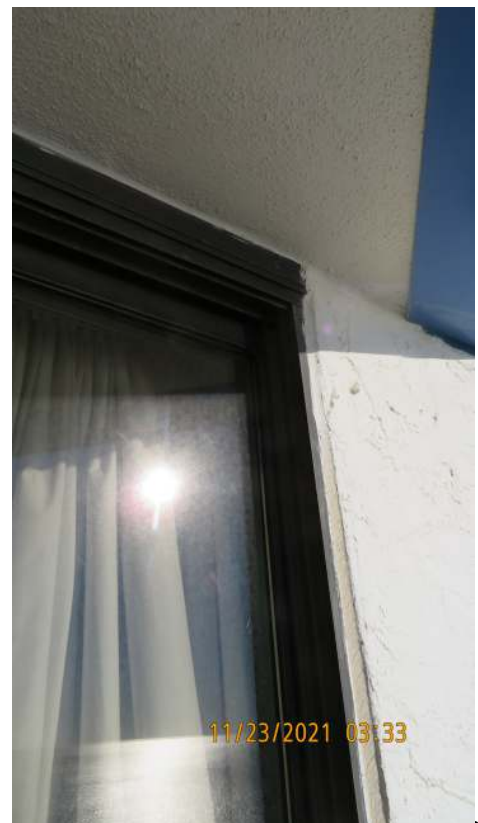
Lastly, the sliding glass doors and windows have single pane glass. The frames are not thermally broken. The glass does not have Low-E coating to reflect the infrared and ultraviolet light from entering through the glass into the unit. Both issues add a significant amount of heat gain in the summer and heat loss in the winter. It is estimated that the cost per unit with new insulated coated glass would reduce the cost of conditioning air by 20% to 30%.

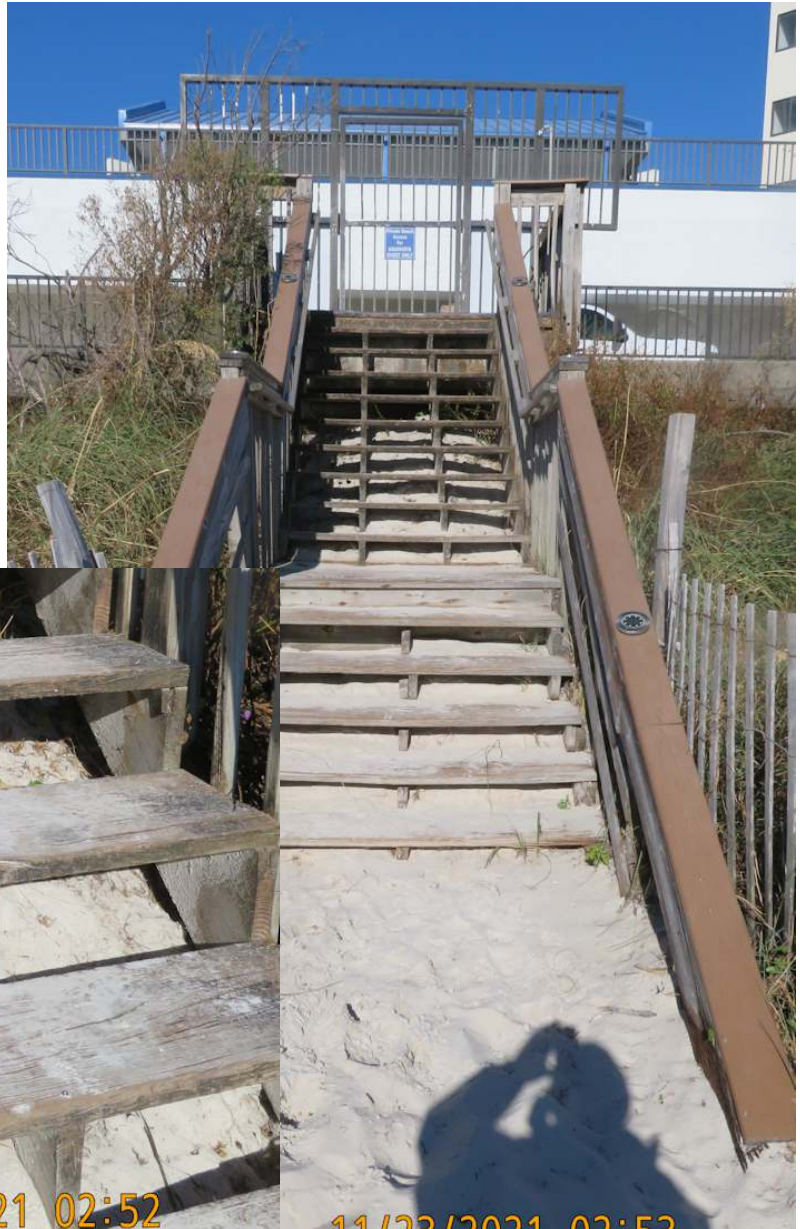
**Beach Walkover:**

The beach walkover has also reached its service life and should be reconstructed.

As part of this reconstruction, the owners may wish to provide shorter runs and larger longer landings to stretch the walkover down to the edge of the sea oats.
