29 November 2021

TO: Board of Directors  
**Aquavista of Panama City Beach Owners Association, Inc.**

Subject: **Building Survey of the Property**

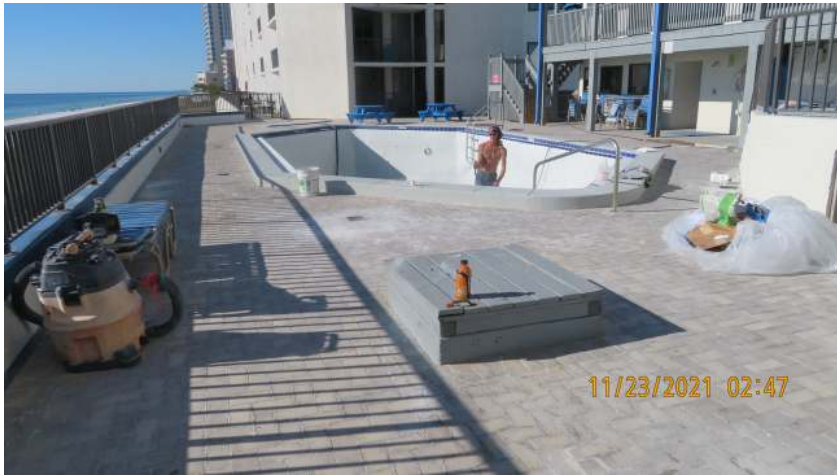
## TOWERS AND POOL CONCRETE SLAB DECK

The structure beneath the two towers and pool deck are poured-in-place concrete columns and large girders running north and south. Fortunately, the balcony deck at this level east and west of the pool has a waterproof coating applied several years ago which has aided in protecting the concrete deck.

As can be seen in the adjacent and following page photographs, the primary girders and columns have structural cracks that should be repaired. In some cases, one can see that the reinforcing steel is beginning to rust and bleeding through the surface.
